Tactile Inspection of Concrete Deterioration in Sewers with Legged Robots

Hendrik Kolvenbach, Giorgio Valsecchi, Ruben Grandia,
Antoni Ruiz, Fabian Jenelten and Marco Hutter

Abstract We present a tactile inspection approach for legged robots which allows for evaluating concrete deterioration in medium to large-sized sewers. The legged robot, to this end, executes a well-defined scratching motion with one limb on the sewer floor. Inertial and Force/Torque sensors implemented in specially designed feet capture the resulting vibration. The data is used with concrete deterioration estimates from professional sewer inspectors to train a support vector machine. We achieved deterioration level estimates within three classes of over 92% accuracy. The dataset, which we recorded during a field test campaign in the sewers of Zurich is made publicly available.

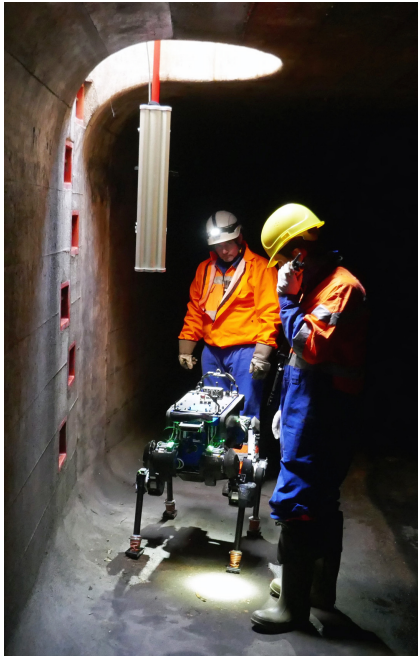
(a) *ANYmal* setup in the sewer

(b) Walking on biofilm

(c) Walking through wastewater

Fig. 5: Depictions of *ANYmal* walking in the sewer. A professional sewer inspector accompanies the testing and assesses the state of the concrete.

The base station consists of the operator PC, an additional screen and outlets for electricity and communication links to the robot. Additionally, the base station is easy to transport and quick to set up. A directional Wi-Fi antenna (Ubiquiti airMAX) was deployed into the utility hole via a tripod with reversed column and enabled a reliable communication link to the robot. During the test, an operator stayed in the sewers with a professional inspector and communicated with the robot operator outside via walkie-talkies (Figure 5).

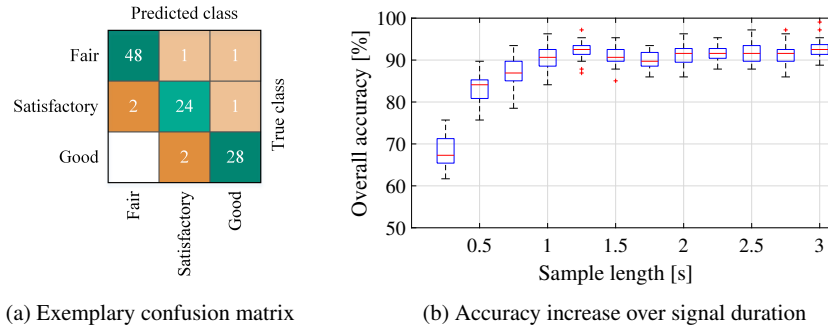
Fig. 8: Few misclassification events occur between classes. Correlation between classification accuracy and signal length indicates that samples should be collected for at least one second after initializing the inspection motion.

Performing the classification with the two IMU's resulted in the highest accuracy and further investigations were performed with this setup. Investigating the misclassified samples showed no specific preference to location or surface condition. Fewer samples were available for the *satisfactory* class compared to the *good* and *fair* class, which might explain the general lower classification performance on the validation set. An exemplary confusion matrix for evaluating the validation set can be seen in Figure 8. Investigating the sampling time shows that the signals should be captured for at least one second after the motion is initiated to achieve a high classification accuracy. Longer sampling times increase the performance only marginally. In practice, human inspectors are scratching the sewer frequently with their feet during a walk through to get a better understanding of the damages.
