Comparison of Geotechnical Investigation
Results with Encountered Ground Conditions
During Subsea Tunnelling in Qatar

Comparison of Geotechnical investigation results with Encountered ground conditions during subsea tunnelling in Qatar

Project Coordinator of Musaimeer Pumping Station and Outfall Project,
Public Works Authority
Doha, Qatar

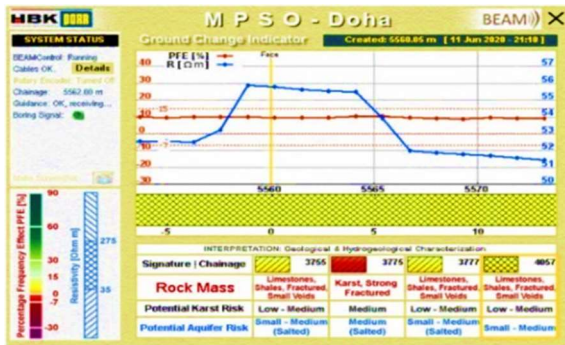
Figure 10(a): Fault zone F10

In figure 10 the bored tunnelling electric ahead meter (BEAM) display indicates the results of crossing two anomaly zones identified by the post tender geotechnical surveys.

Figure 10: BEAM Display at Fault zone F10 – F13

It is important to note that there are limitations on the precision accuracy of the system. The system is not able to identify whether the TBM is passing through Rus formation, Midra Shale or Simsim limestone, it can only identify intrinsic properties of rock mass. It is not possible to measure the exact amount of water inflow and location. The system can provide an estimation of the possibility that water inflow or aquifers might be encountered.
